Safety Inspection Report

Annual Inspection

Waldringfield Playing Field

Waldringfield Parish Council

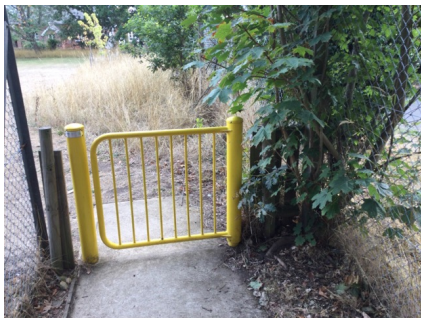
Encroaching vegetation or trees.

Remove.

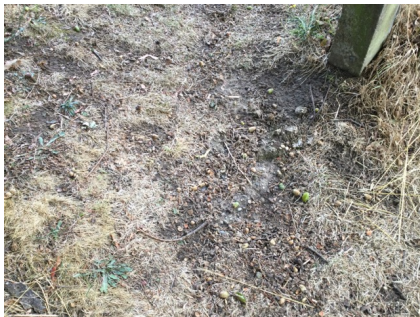
Trip points on the surface.

Located around entrance.

Make level.

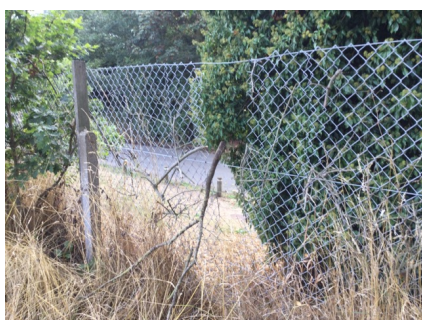
Item is damaged.

Repair / replace damaged sections.

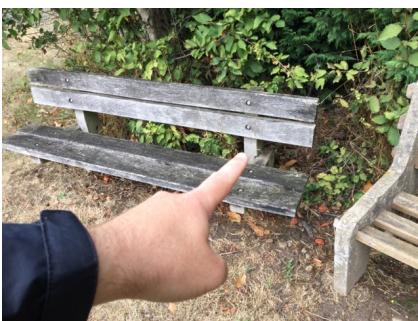
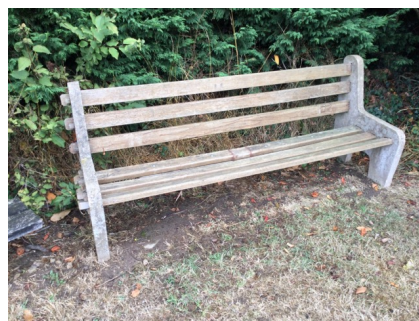
Loose in ground.

Partial timber bench is loose in the ground and our inspector recommends permanently fixing the bench to the ground reducing the risk of the bench toppling over.

Timber bench is loose in the ground on one side. Reset.

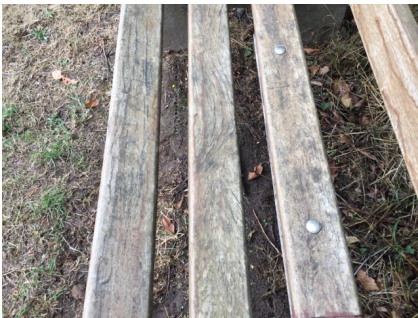
The gaps between the slats exceed 30 mm and are known to cause entrapments.

No reasonably practicable action is identified.

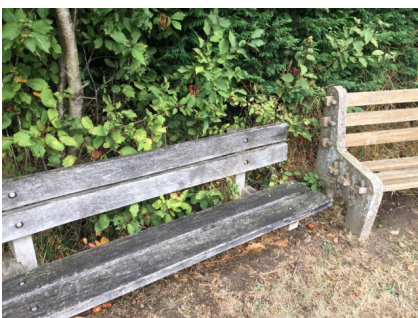
Encroaching vegetation or trees.

Remove.

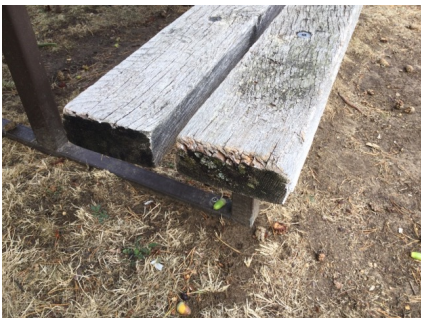
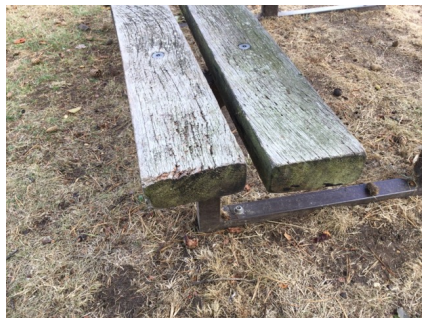
Timber is splintered.

Repair.

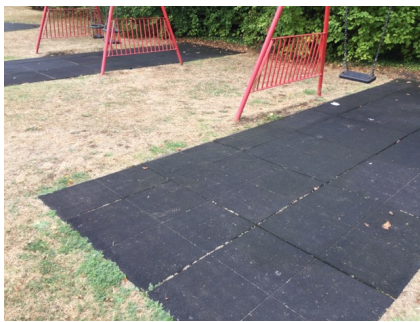
Algae growth giving slippery conditions.

Both swing surfaces are algae and moss covered providing a slippery surface when wet.

Powerwashing is recommended. Care should be taken to ensure that the material can sustain high pressure washing.

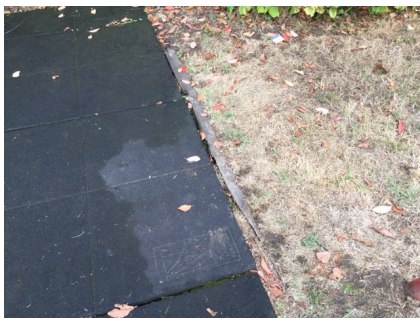
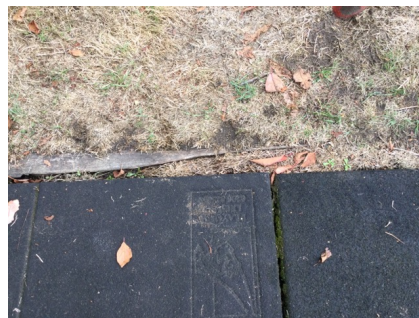
Item has some parts missing.

Sections of timber edge boarding are missing and decayed. Replace affected areas.

Replace the missing parts.

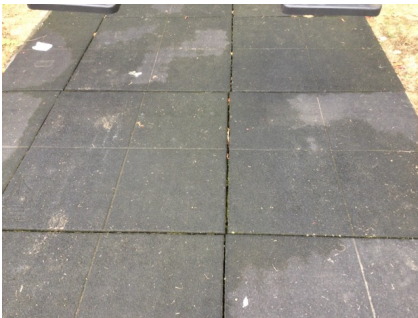
Gaps between the tiles present hazards.

Eliminate the gaps.

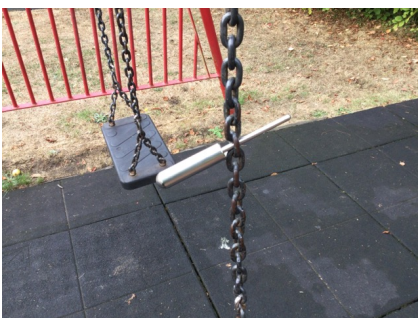
Finger entrapment.

Chain link gaps.

Read the notes for further action.

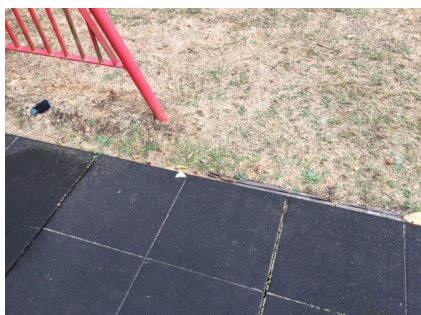
Item has some parts missing.

Sections of timber edge boarding are missing and decayed. Replace affected areas.

Replace the missing parts.

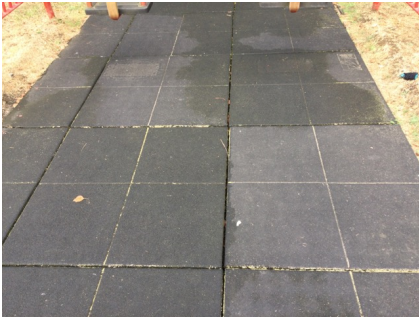
Gaps between the tiles present hazards.

Eliminate the gaps.

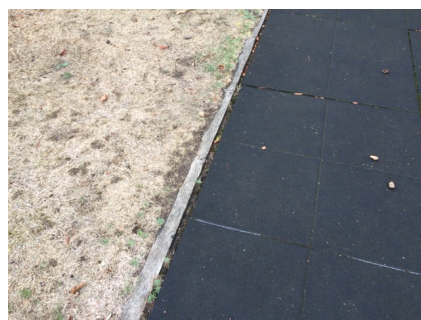
Gaps between the tiles present hazards.

Large gaps are present between tiles.

Eliminate the gaps.

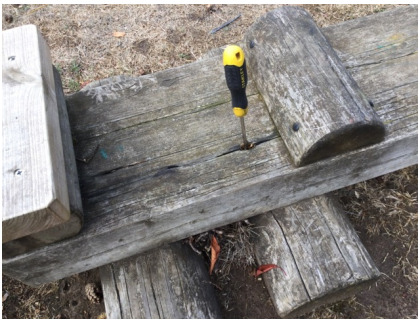
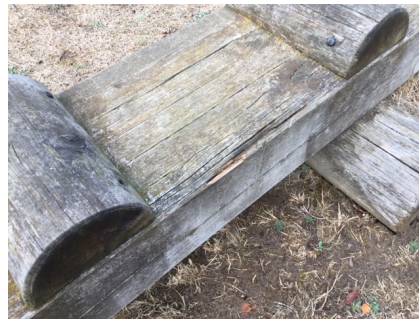
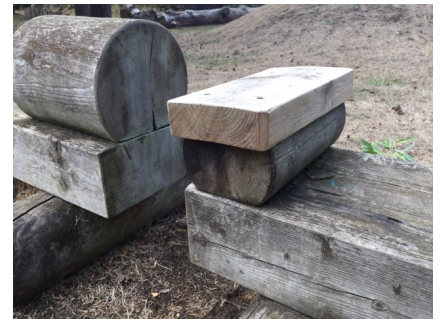
Timber is decayed.

Newly installed timber has been fixed to a decayed log section. Replace. Carriage section is decaying and splintered. Repair and replace when necessary. Monitor all timbers throughout the year due to timbers starting to soften.

Check on a routine basis., Replace affected parts.

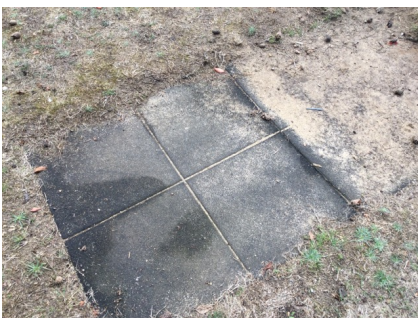
Gaps between the tiles present hazards.

Eliminate the gaps.

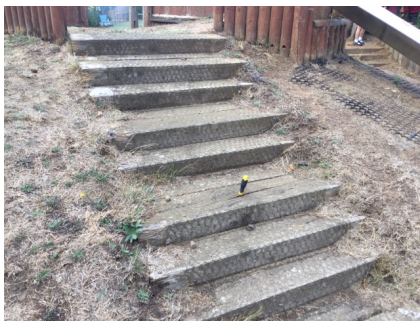
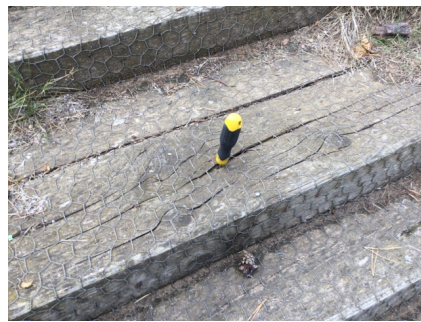
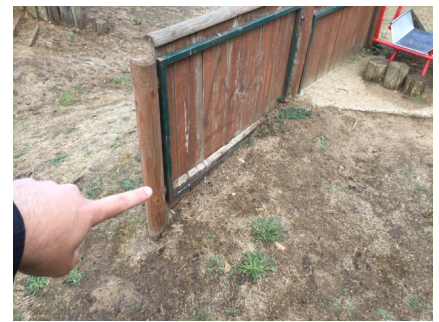
Timber is decayed.

Multiple access step sleepers are decayed on tops and hollow. Replace affected timbers.

Barrier post is decayed through at ground level and loose. Replace.

Check on a routine basis., Replace affected parts.

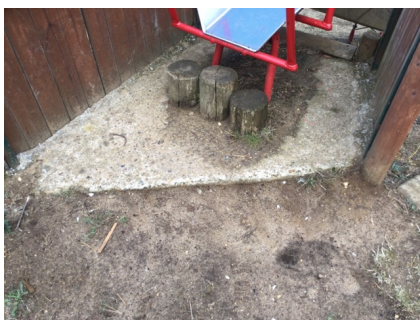
Trip points on the surface.

Slight trip point present around entrance to the embankment slide.

Make level.

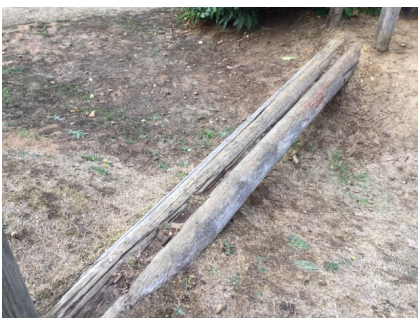
The top of the beam should be made non-slip by the addition of surface textures or cross-cutting.

Make the top of the beam non-slip by the addition of surface textures or cross-cutting.

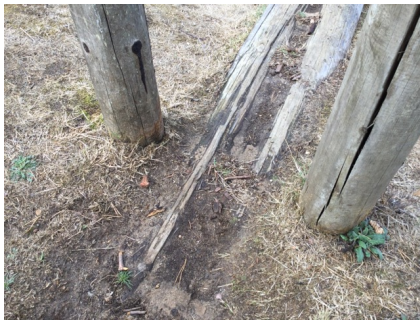
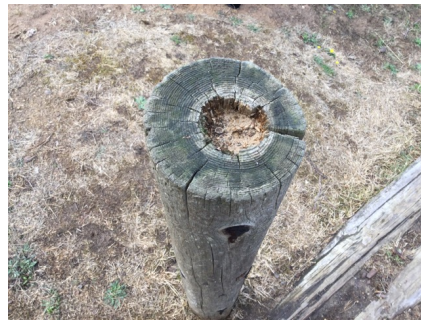
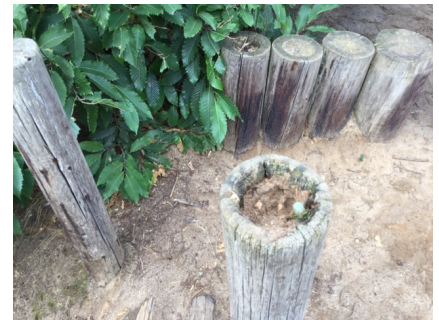
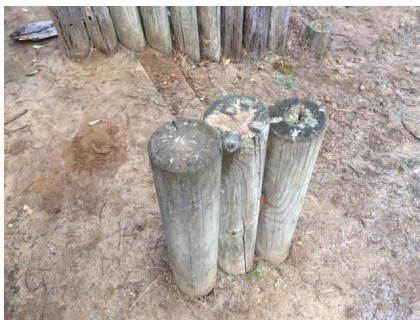
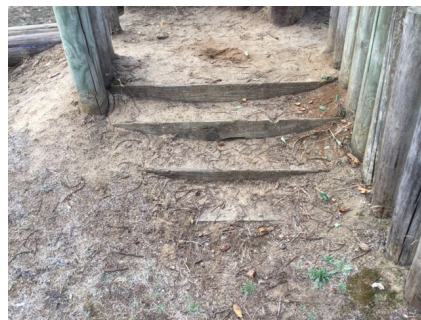
Timber is decayed.

Several post tops are decayed through on tops and at ground level. Consider replacing.

Access steps leading to bridge section are decayed. Replace.

Beams on bridge are decaying on tops. Monitor and replace when necessary.

Check on a routine basis., Replace affected parts., We recommend resistance penetration testing to determine the internal condition of the timber. We can undertake this testing at additional cost. Please contact us for details.

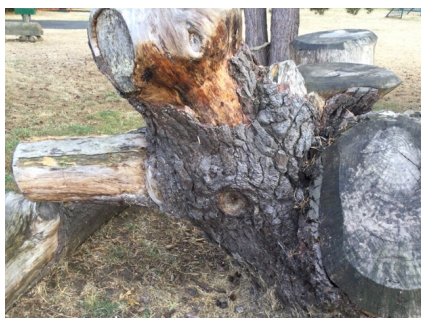
Hard or sharp projections.

Our inspector recommends removing the bark from the logs due to the bark creating sharp edges and projections.

Remove hard, pointed and sharp projections.

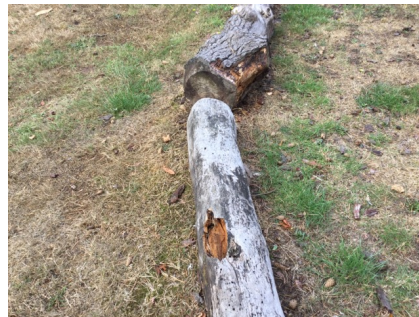
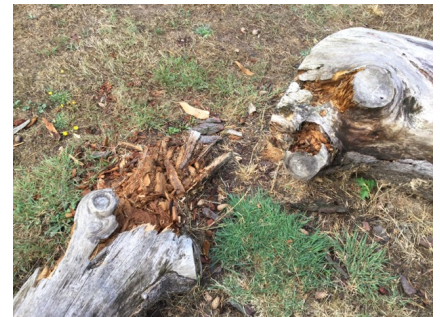
Timber is decayed.

Tree logs and stumps are decaying and splintered.

Check on a routine basis., Replace affected parts.

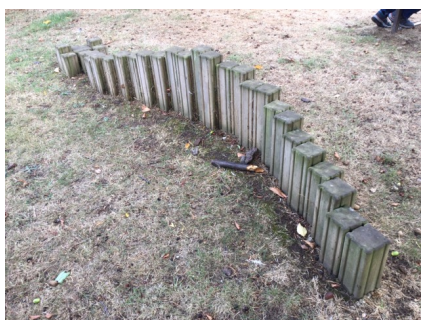
The timber components are slippery.

Timbers are algae covered providing a slippery surface when wet.

Remove slipperiness. Consider adding surface texture.

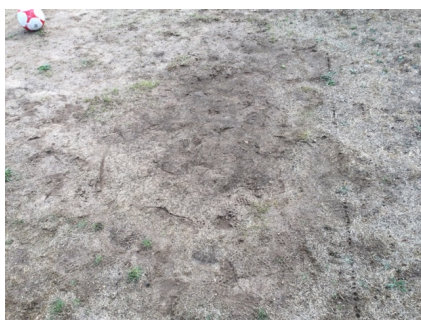
Ground erosion present.

Around goal mouths.

Repair the worn areas.

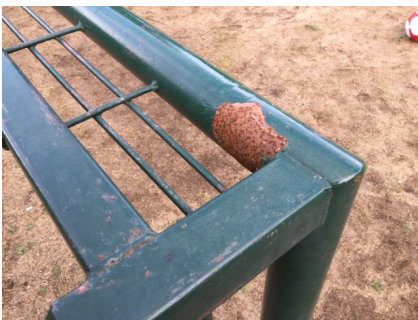
Paintwork is in poor condition.

De-scale back to good base material and coat with lead free paint, using appropriate precautions. Repairs may be necessary where corrosion is severe.

Descale and repaint.

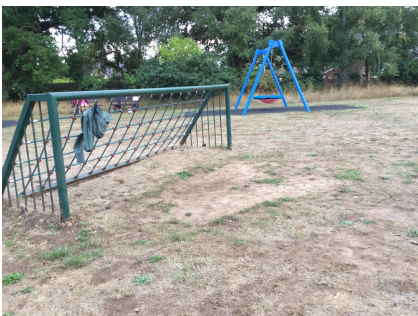
Risk assessment.

Balls may leave the area and strike a user of the play equipment.

Read the notes for further action.
